**Flood Control Project Maintenance
Levee Inspections**

Maintenance Issue Types Only, Levee Inspection Report By Mile - Fall 2016

Reclamation District No. 1001 Nicolaus

Waterway	Bank	Unit Miles	Inspection Start/End	Inspector
Unit No. 01 Yankee Slough	Right	4.12	09/20/2016 09/20/2016	Sterling York

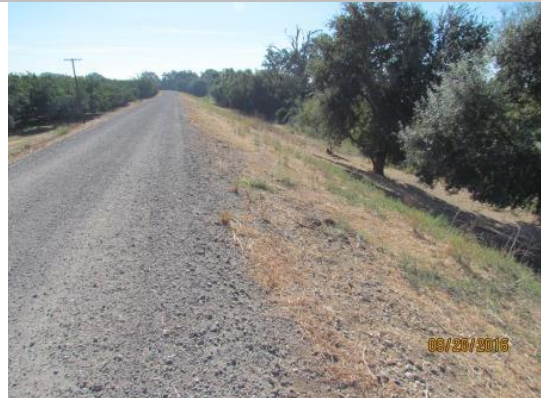
Photo 1 of 1 : FA_2016_RD1001_36_17_20160926_00014.jpg

LM Start	0.01	Rating **	A	Issue No.	17
LM End	3.83	Issue Type +	Ma	Location *	WS
Category	Earthen Levee		GPS Latitude/Longitude		
			Start	End	
Item	Vegetation		38.980181°	38.966785°	
			-121.470314°	-121.533482°	
DWR ID	DWR_RD1001_01_f_2016_17				
Comment Code					
V1 : Control annual grass and weeds on the levee slopes and easements.					
Inspector Comment

View of the maintained vegetation on the waterside looking upstream.
Fall 2016.

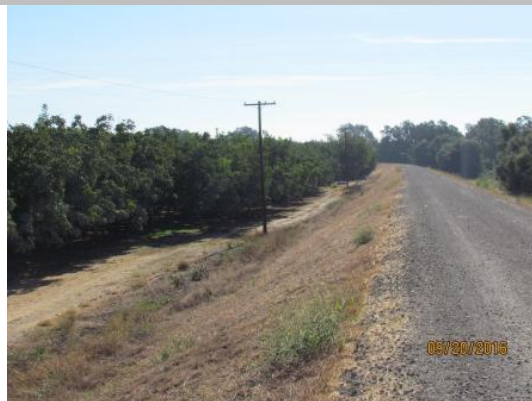
Photo 1 of 1 : FA_2016_RD1001_36_13_20160926_00015.jpg

View of the maintained vegetation on the landside looking upstream. Fall 2016.

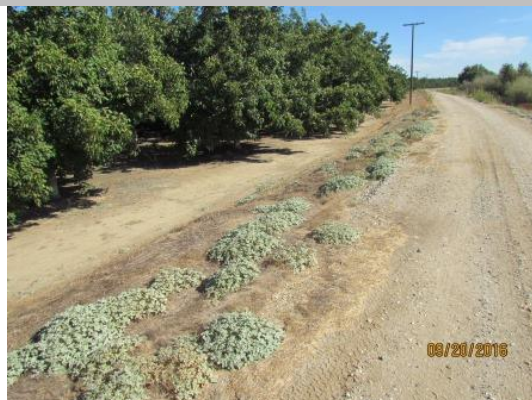
Photo 1 of 1 : FA_2016_RD1001_36_25_20160926_00029.jpg

LM Start	1.40	Rating **	M	Issue No.	25
LM End	1.40	Issue Type +	Ma	Location *	LS
Category	Earthen Levee			GPS Latitude/Longitude	
				Start	End
Item	Slope Stability			38.971589°	38.971589°
				-121.492049°	-121.492049°
DWR ID	DWR_RD1001_01_f_2016_25				
Comment Code					
S3 : Repair the levee slope damaged by vehicle traffic and prevent access where possible.					
Inspector Comment

View of tier ruts on the landside levee slope looking upstream. Fall 2016.

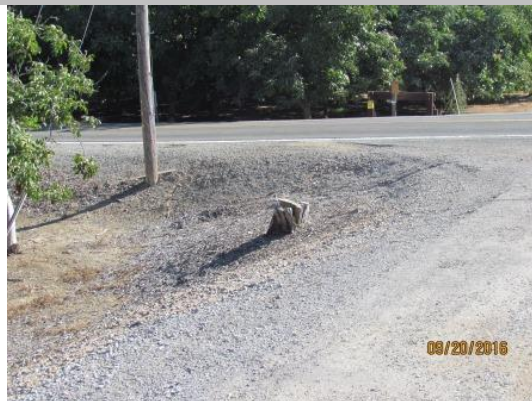
Photo 1 of 1 : FA_2016_RD1001_36_10_20160926_00023.jpg

View of stump on the landside slope looking upstream. Fall 2016.

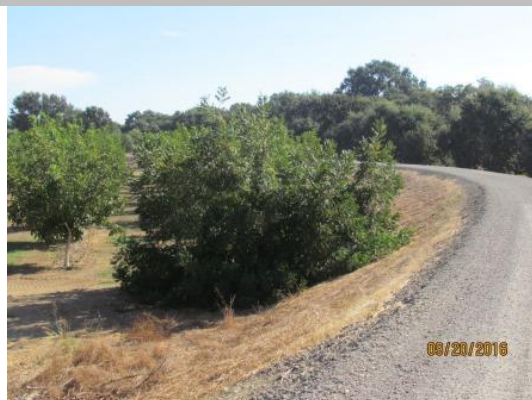
Photo 1 of 1 : FA_2016_RD1001_36_19_20160926_00022.jpg

LM Start	3.09	Rating **	M	Issue No.	19
LM End	3.09	Issue Type +	Ma	Location *	LS
Category	Earthen Levee			GPS Latitude/Longitude	
				Start	End
Item	Trim / Thin Trees			38.965660 °	38.965660 °
				-121.520548 °	-121.520548 °
DWR ID	DWR_RD1001_01_s_2016_19				
Comment Code					
T1 : Trim trees to at least five feet above ground level.					
Inspector Comment

View of a tree that need limbs trimmed. Fall 2016.

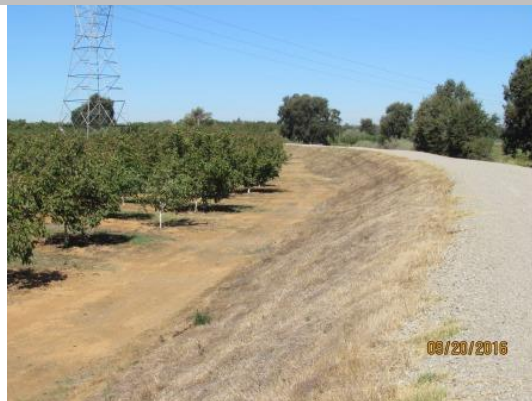
Photo 1 of 1 : FA_2016_RD1001_35_15_20160926_00020.jpg

View of landside looking down stream of maintained annual grasses.
Fall 2016.

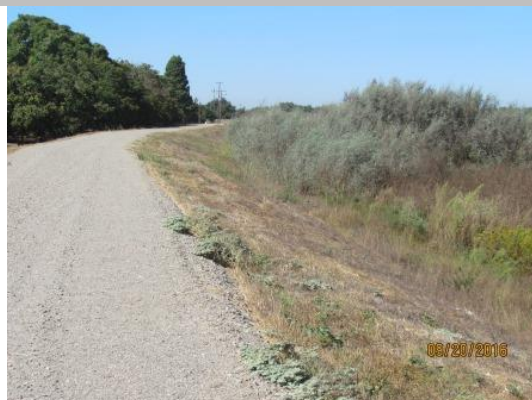
Photo 1 of 1 : FA_2016_RD1001_35_17_20160926_00022.jpg

LM Start	0.01	Rating **	A	Issue No.	17
LM End	3.65	Issue Type +	Ma	Location *	WS
Category	Earthen Levee			GPS Latitude/Longitude	
				Start	End
Item	Vegetation			38.971285 °	38.965840 °
				-121.474020 °	-121.533681 °
DWR ID	DWR_RD1001_02_f_2016_17				
Comment Code					
V1 : Control annual grass and weeds on the levee slopes and easements.					
Inspector Comment

View of waterside looking down stream of maintained annual grasses.
Fall 2016.

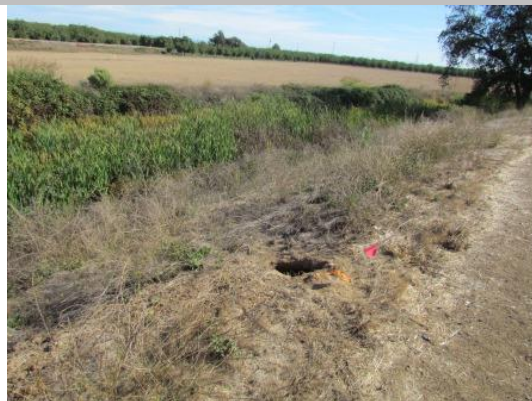
Photo 1 of 3 : FA_2016_RD1001_35_4_20160906_00001.jpg

LM Start	0.27	Rating **	A/W	Issue No.	4
LM End	0.27	Issue Type +	Ma	Location *	WS
Category	Earthen Levee			GPS Latitude/Longitude	
				Start	End
Item	Animal Control			38.974323 °	38.974323 °
				-121.476442 °	-121.476442 °
DWR ID	DWR_RD1001_02_f_2014_4				
Comment Code					
A3 : No rodents visible, but rodent burrows visible; need to backfill and compact or grout burrows.					
Inspector Comment					
There is no animal activity at this location, the existing hole near the crown needs to be repaired, Fall 2016.

This photo was taken from the levee crown facing east looking down the waterward slope at an animal burrow. Fall 2014.

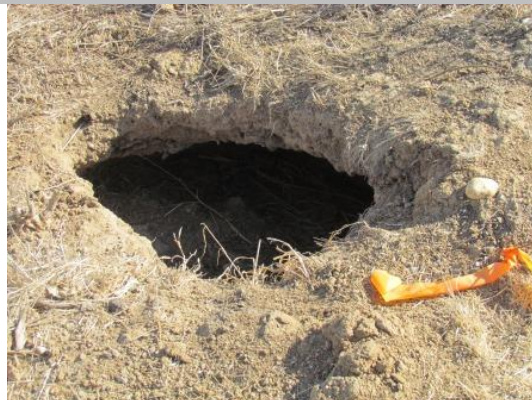
Photo 2 of 3 : FA_2016_RD1001_35_4_20160906_00002.jpg

Another picture of the animal burrow. Fall 2014.

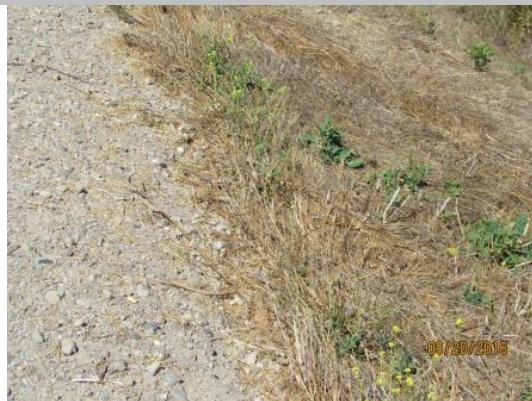
Photo 3 of 3 : FA_2016_RD1001_35_4_20160926_00021.jpg

LM Start	0.27	Rating **	A/W	Issue No.	4 (cont)	
LM End	0.27	Issue Type +	Ma	Location *	WS	
Category	Earthen Levee			GPS Latitude/Longitude		
				Start		End
Item	Animal Control			38.974323 °		38.974323 °
				-121.476442 °		-121.476442 °
DWR ID	DWR_RD1001_02_f_2014_4					
Comment Code						
A3 : No rodents visible, but rodent burrows visible; need to backfill and compact or grout burrows.						
Inspector Comment						
There is no animal activity at this location, the existing hole near the crown needs to be repaired, Fall 2016.

Although hard to see with the grass, there is still an animal hole on waterward levee slope near the crown at this location. Hole was approximately 1' in diameter and 8" deep that needs to be repaired. There is no animal activity at this location. Fall 2016.

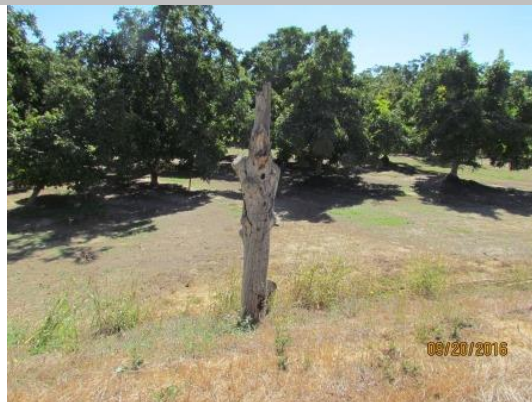
Photo 1 of 1 : FA_2016_RD1001_35_6_20160926_00029.jpg

View of large stump at the landside levee toe. Fall 2016.

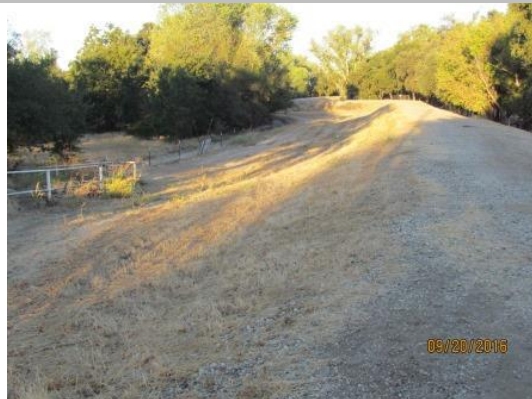
Photo 1 of 1 : FA_2016_RD1001_37_16_20160926_00037.jpg

View of maintained vegetation on the landside looking downstream. Fall 2016.

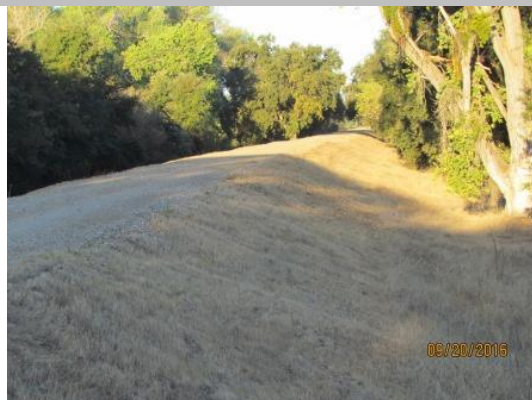
Photo 1 of 1 : FA_2016_RD1001_37_18_20160926_00038.jpg

LM Start	0.01	Rating **	A	Issue No.	18	
LM End	12.57	Issue Type +	Ma	Location *	WS	
Category	Earthen Levee			GPS Latitude/Longitude		
				Start		End
Item	Vegetation			39.006601 °		38.941187 °
				-121.375288 °		-121.567582 °
DWR ID	DWR_RD1001_03_f_2016_18					
Comment Code						
V1 : Control annual grass and weeds on the levee slopes and easements.						
Inspector Comment

View of maintained vegetation on the waterside looking downstream. Fall 2016.

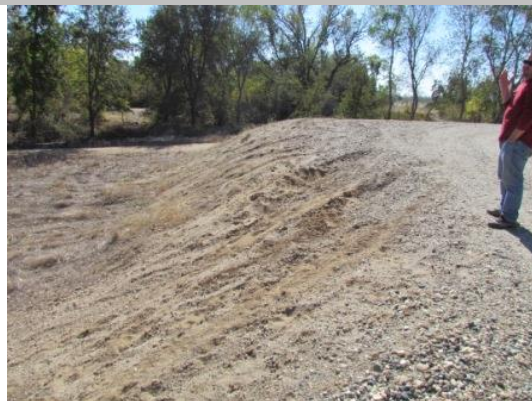
Photo 1 of 2 : FA_2016_RD1001_37_2_20160906_00003.jpg

LM Start	0.11	Rating **	M	Issue No.	2
LM End	0.11	Issue Type +	Ma	Location *	CR
Category	Earthen Levee			GPS Latitude/Longitude	
				Start	End
Item	Slope Stability			39.006569 °	39.006569 °
				-121.377037 °	-121.377037 °
DWR ID	DWR_RD1001_03_f_2013_2				
Comment Code					
S3 : Repair the levee slope damaged by vehicle traffic and prevent access where possible.					
Inspector Comment					
Rutting caused by vehicles driving up the landward levee slope.

This photo was taken from the crown of the levee facing west looking down the slope at rutting caused by vehicles driving up the landward levee slope. Fall 2015.

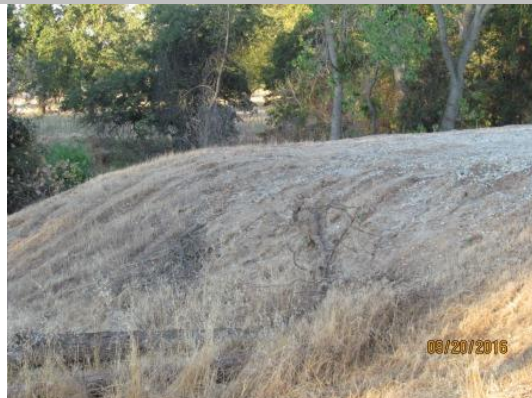
Photo 2 of 2 : FA_2016_RD1001_37_2_20160926_00039.jpg

View of the same rutting on the landside of the levee facing downstream. Fall 2016.

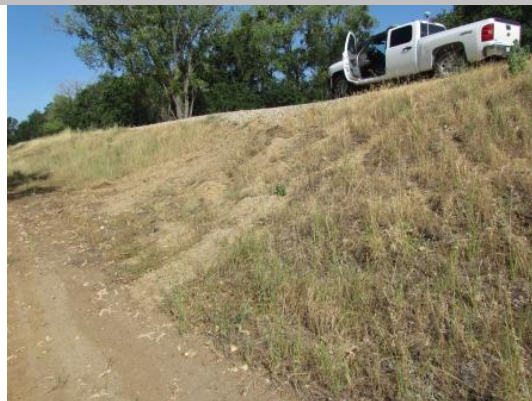
Photo 1 of 1 : FA_2016_RD1001_37_23_20160906_00014.jpg

LM Start	0.14	Rating **	M	Issue No.	23
LM End	0.14	Issue Type +	Ma	Location *	LS
Category	Earthen Levee			GPS Latitude/Longitude	
				Start	End
Item	Slope Stability			39.006351°	39.006351°
				-121.377313°	-121.377313°
DWR ID	DWR_RD1001_03_s_2015_23				
Comment Code					
S3 : Repair the levee slope damaged by vehicle traffic and prevent access where possible.					
Inspector Comment					
Rutting caused by vehicles driving up the landward levee slope.

View of the rutting on the landside of the levee from the toe facing downstream.

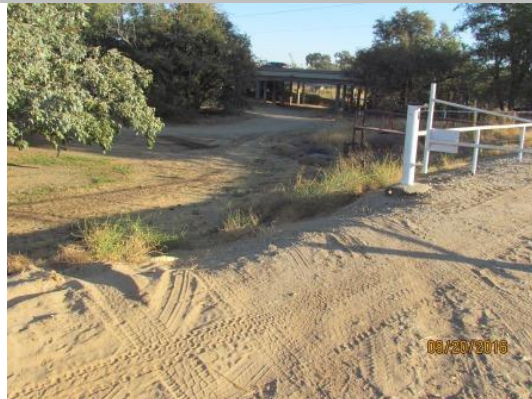
Photo 1 of 1 : FA_2016_RD1001_37_28_20160926_00041.jpg

LM Start	1.87	Rating **	A/W	Issue No.	28
LM End	1.87	Issue Type +	Ma	Location *	WS
Category	Earthen Levee			GPS Latitude/Longitude	
				Start	End
Item	Slope Stability			38.998608 °	38.998608 °
				-121.405570 °	-121.405570 °
DWR ID	DWR_RD1001_03_s_2013_28				
Comment Code					
S3 : Repair the levee slope damaged by vehicle traffic and prevent access where possible.					
Inspector Comment					
Continual damage to waterside slope caused by vehicles, suggest blocking access.

Continual damage to waterside slope caused by vehicles. Fall 2016.

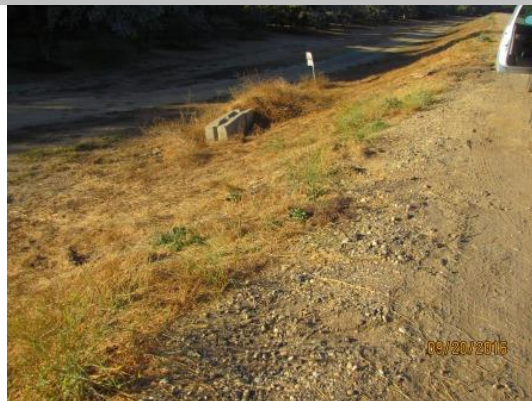
Photo 1 of 1 : FA_2016_RD1001_37_29_20160926_00042.jpg

LM Start	1.87	Rating **	A/W	Issue No.	29
LM End	1.87	Issue Type +	Ma	Location *	LS
Category	Earthen Levee			GPS Latitude/Longitude	
				Start	End
Item	Slope Stability			38.998608 °	38.998608 °
				-121.405570 °	-121.405570 °
DWR ID	DWR_RD1001_03_s_2013_29				
Comment Code					
S3 : Repair the levee slope damaged by vehicle traffic and prevent access where possible.					
Inspector Comment					
Continual damage caused by vehicles going around the gate, suggest blocking access.

Continual damage caused by vehicles going around the gate. Fall 2016

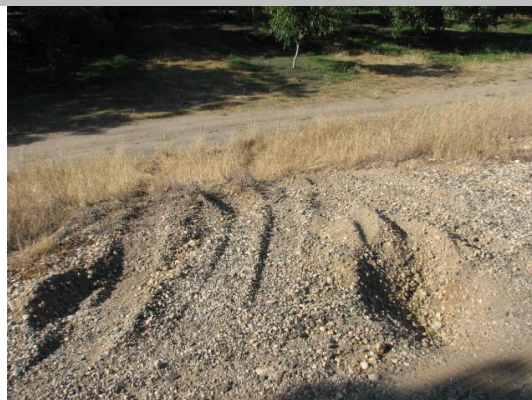
Photo 1 of 2 : FA_2016_RD1001_37_30_20160906_00020.jpg

LM Start	2.28	Rating **	A/W	Issue No.	30
LM End	2.28	Issue Type +	Ma	Location *	LS
Category	Earthen Levee			GPS Latitude/Longitude	
				Start	End
Item	Slope Stability			38.996302 °	38.996302 °
				-121.412285 °	-121.412285 °
DWR ID	DWR_RD1001_03_s_2013_30				
Comment Code					
S3 : Repair the levee slope damaged by vehicle traffic and prevent access where possible.					
Inspector Comment					
Damage to landside slope has been repaired. Continue to monitor area.

Damage caused by vehicles. Spring 2013

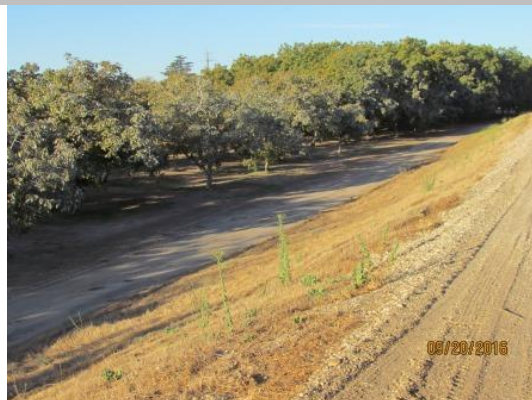
Photo 2 of 2 : FA_2016_RD1001_37_30_20160926_00043.jpg

Damage to landside slope has been repaired. Fall 2016.

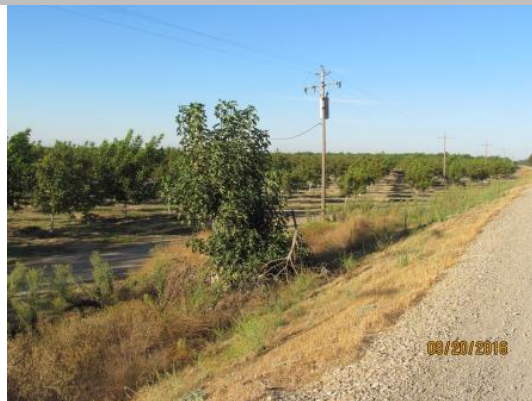
Photo 1 of 1 : FA_2016_RD1001_37_36_20160926_00045.jpg

View of a small starter tree on landside slope looking downstream that is less than 4" in diameter.

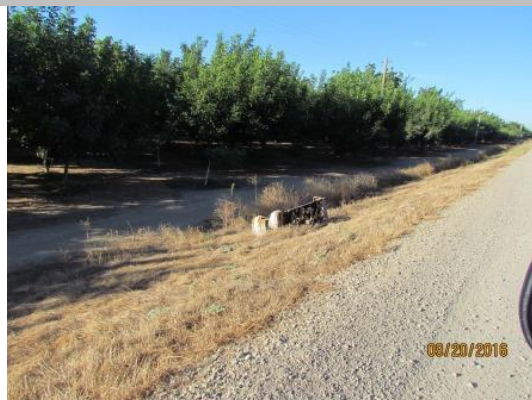
Photo 1 of 1 : FA_2016_RD1001_37_42_20160926_00048.jpg

View of a couch on the landside levee slope looking downstream. Fall 2016.

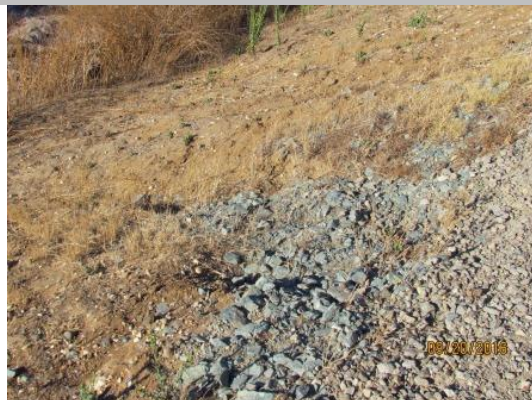
Photo 1 of 1 : FA_2016_RD1001_37_31_20160926_00055.jpg

LM Start	4.48	Rating **	M	Issue No.	31
LM End	4.48	Issue Type +	Ma	Location *	LS
Category	Earthen Levee			GPS Latitude/Longitude	
				Start	End
Item	Slope Stability			38.991851 °	38.991851 °
				-121.452116 °	-121.452116 °
DWR ID	DWR_RD1001_03_f_2016_31				
Comment Code					
S1 : Repair slope instability.					
Inspector Comment

View of erosion in the landside levee slope looking downstream. Fall 2016.

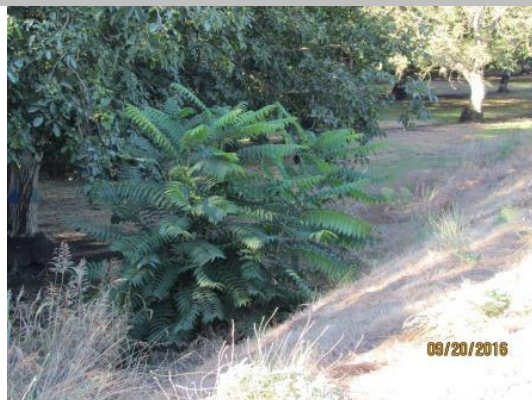
Photo 1 of 1 : FA_2016_RD1001_37_32_20160926_00056.jpg

View of starter tree with diameter less than 4". Fall 2016.

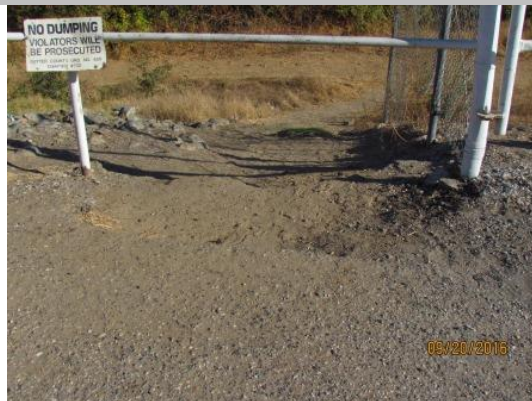
Photo 1 of 1 : FA_2016_RD1001_37_40_20160926_00058.jpg

LM Start	6.47	Rating **	M	Issue No.	40
LM End	6.47	Issue Type +	Ma	Location *	WS
Category	Earthen Levee			GPS Latitude/Longitude	
				Start	End
Item	Slope Stability			38.984020°	38.984020°
				-121.487404°	-121.487404°
DWR ID	DWR_RD1001_03_f_2016_40				
Comment Code					
S2 : Repair the levee slope damaged by foot traffic and prevent access where possible.					
Inspector Comment

View of slope instability on the waterside at gate caused by foot traffic. Fall 2016.

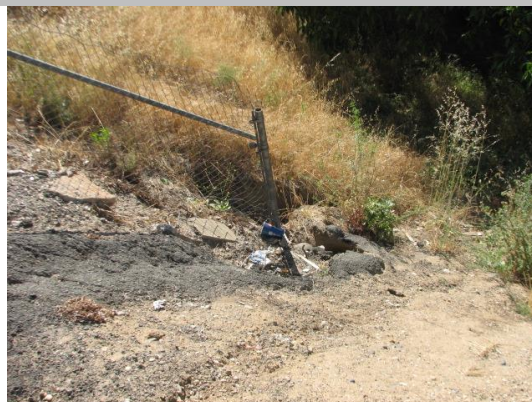
Photo 1 of 2 : FA_2016_RD1001_37_38_20160906_00022.jpg

LM Start	6.47	Rating **	M	Issue No.	38
LM End	6.47	Issue Type +	Ma	Location *	LS
Category	Earthen Levee			GPS Latitude/Longitude	
				Start	End
Item	Erosion / Bank Caving			38.984019 °	38.984019 °
				-121.487404 °	-121.487404 °
DWR ID	DWR_RD1001_03_s_2013_38				
Comment Code					
E2 : Schedule repair of erosion site prior to the next inspection.					
Inspector Comment

Erosion caused by run off from the roadway. Spring 2013

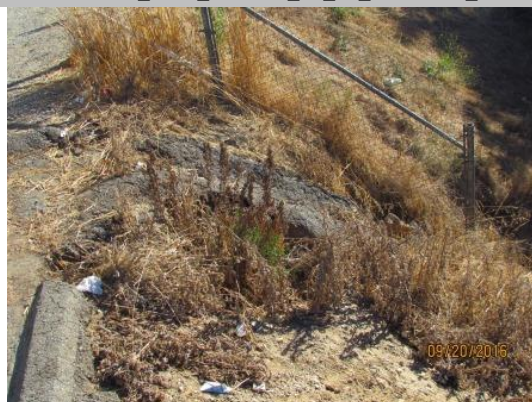
Photo 2 of 2 : FA_2016_RD1001_37_38_20160926_00057.jpg

Erosion caused by run off from the roadway still exist. Fall 2016.

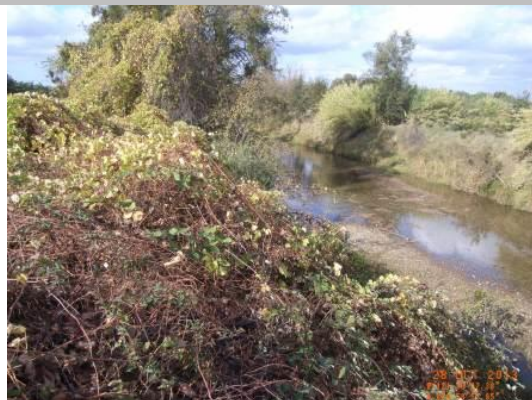
Photo 1 of 1 : FA_2016_RD1001_37_17_20160906_00012.jpg

LM Start	7.22	Rating **	M	Issue No.	17
LM End	7.31	Issue Type +	Ma	Location *	WS
Category	Supplemental			GPS Latitude/Longitude	
				Start	End
Item	2015 USACE Erosion Survey, DRAFT			38.982737 °	38.982572 °
				-121.501144 °	-121.502797 °
DWR ID	DWR_RD1001_03_s_2016_17				
Comment Code					
Inspector Comment					
2008 - Sandy/silty banks with rotational slab failures creating near vertical bank with pop-outs due to tree failures. Narrow berm. 2015: Last observed in 2013. [2015 Site ID: BER_5-7_L]

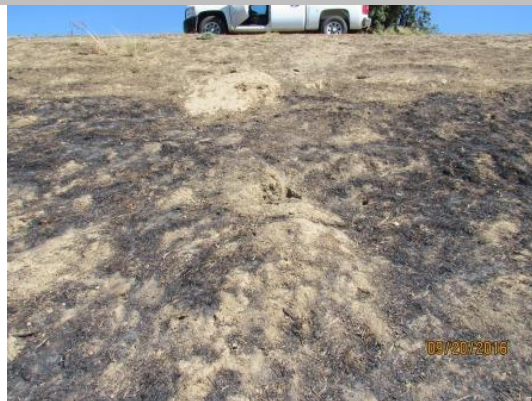
Photo 1 of 1 : FA_2016_RD1001_37_48_20160926_00060.jpg

View of existing rodent hole that are no longer active on the landside slope. Fall 2016.

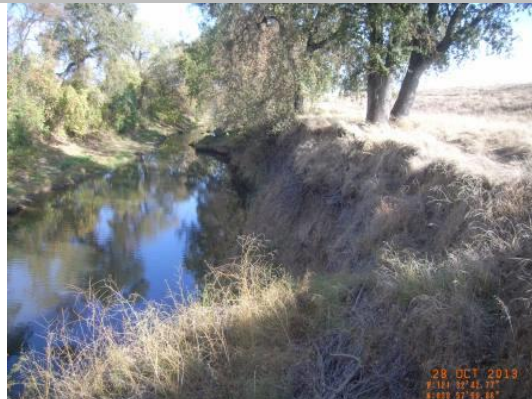
Photo 1 of 1 : FA_2016_RD1001_37_10_20160906_00011.jpg

LM Start	10.36	Rating **	M	Issue No.	10
LM End	10.40	Issue Type +	Ma	Location *	WS
Category	Supplemental			GPS Latitude/Longitude	
				Start	End
Item	2015 USACE Erosion Survey, DRAFT			38.964583 °	38.964010 °
				-121.544967 °	-121.545228 °
DWR ID	DWR_RD1001_03_s_2016_10				
Comment Code					
Inspector Comment					
2011 - Large section of bank has slumped off. RD has flagged and appears to be watching. 2012 - Slopes slightly steeper. 2013 - Minor new erosion observed. 2015: Last observed in 2013. [2015 Site ID: BER_2-5_L]

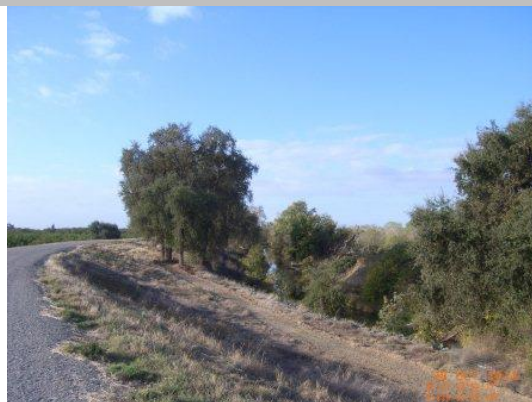
Photo 1 of 1 : FA_2016_RD1001_37_1_20160906_00001.jpg

LM Start	11.08	Rating **	M	Issue No.	1
LM End	11.16	Issue Type +	Ma	Location *	WS
Category	Supplemental			GPS Latitude/Longitude	
				Start	End
Item	2015 USACE Erosion Survey, DRAFT			38.955070 °	38.954227 °
				-121.549528 °	-121.550592 °
DWR ID	DWR_RD1001_03_s_2016_1				
Comment Code					
Inspector Comment					
2011 - Large slumped sections of bank. 2012 - Slopes slightly steeper. 2015: Last observed in 2013. [2015 Site ID: BER_1-9_L]

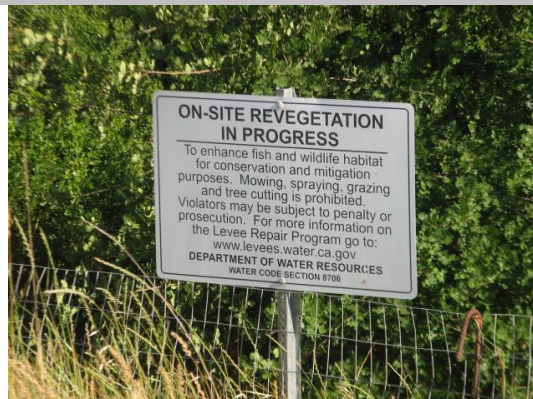
Photo 1 of 1 : FA_2016_RD1001_37_25_20160906_00015.jpg

Revegetation site in progress. Spring 2013

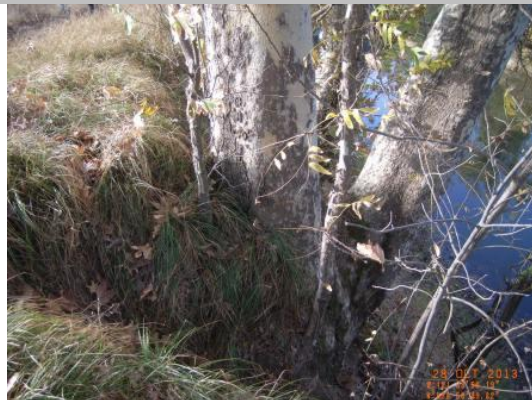
Photo 1 of 1 : FA_2016_RD1001_37_4_20160906_00005.jpg

LM Start	12.07	Rating **	M	Issue No.	4
LM End	12.16	Issue Type +	Ma	Location *	WS
Category	Supplemental			GPS Latitude/Longitude	
				Start	End
Item	2015 USACE Erosion Survey, DRAFT			38.947591 °	38.946477 °
				-121.563390 °	-121.564094 °
DWR ID	DWR_RD1001_03_s_2016_4				
Comment Code					
Inspector Comment					
2006 - Multiple rotational failures in the berm. Erosion is into the levee toe and lower slope. Tension cracks extensive at top of bank. Cohesive toe creates a bench on which failures occur. 2007 - Still steep bank with some berm with pistol-butted reeds. 2012 - Site extended upstream due to additional slumping. Slopes slightly steeper. 2015: Last observed in 2013. [2015 Site ID: BER_0-8_L]

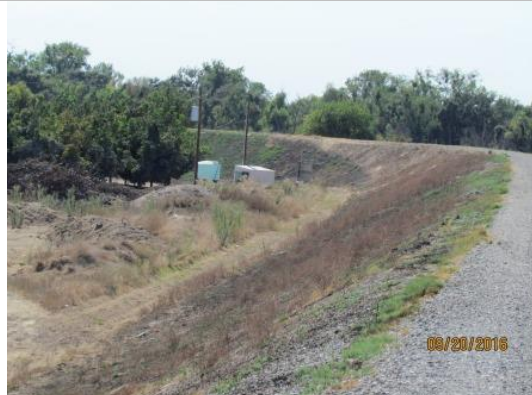
Photo 1 of 1 : FA_2016_RD1001_38_47_20160926_00059.jpg

View of maintained vegetation on the landside looking downstream. Fall 2016.

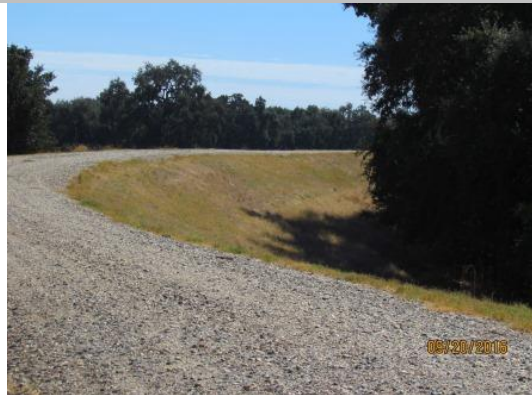
Photo 1 of 1 : FA_2016_RD1001_38_53_20160926_00051.jpg

View of the waterside maintained vegetation looking downstream. Fall 2016.

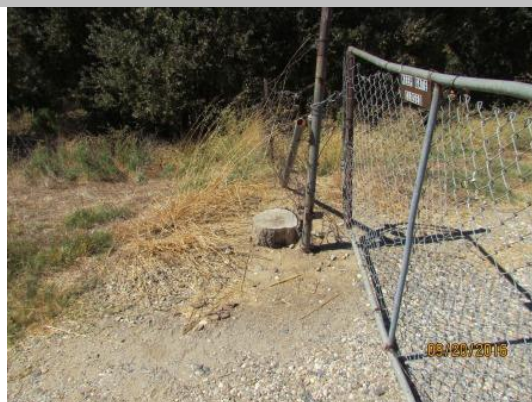
Photo 1 of 1 : FA_2016_RD1001_38_60_20160926_00057.jpg

View of tree stump, waterside crown at gate. Fall 2016.

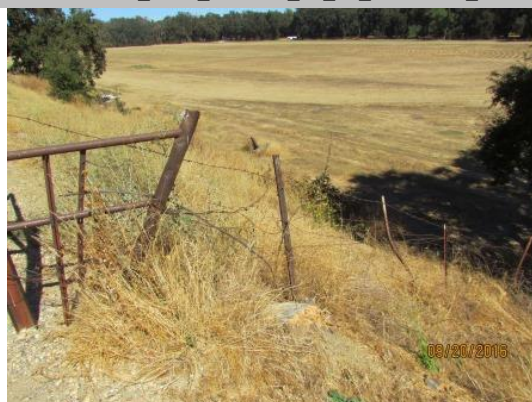
Photo 1 of 1 : FA_2016_RD1001_38_61_20160926_00058.jpg

View of tree stump, landside crown at gate. Fall 2016.

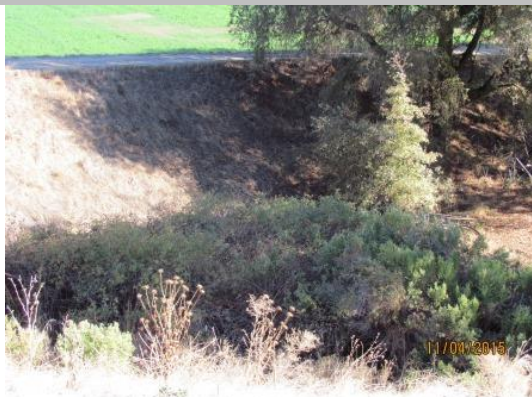
Photo 1 of 1 : FA_2016_RD1001_38_31_20160906_00018.jpg

View of the tall vegetation at the landside levee toe, Fall 2015. As of Fall 2016 the vegetation has been removed.

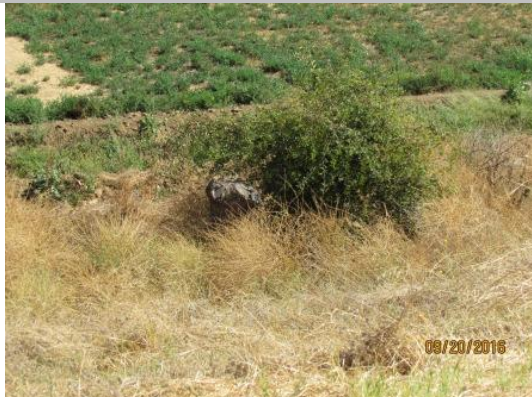
Photo 1 of 1 : FA_2016_RD1001_38_69_20160926_00060.jpg

View of stump at landside levee toe. Fall 2016.

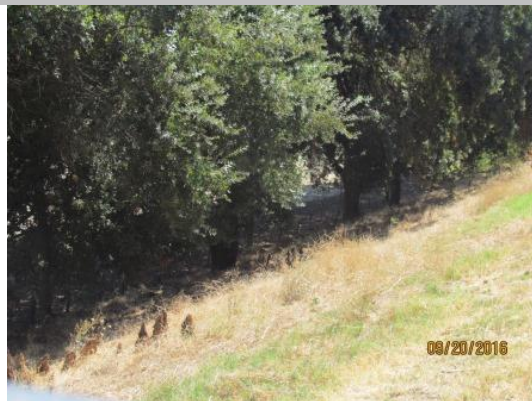
Photo 1 of 1 : FA_2016_RD1001_38_39_20160926_00061.jpg

Tree limbs have been trimmed to allow visibility and access on the landside looking downstream. Fall 2016.

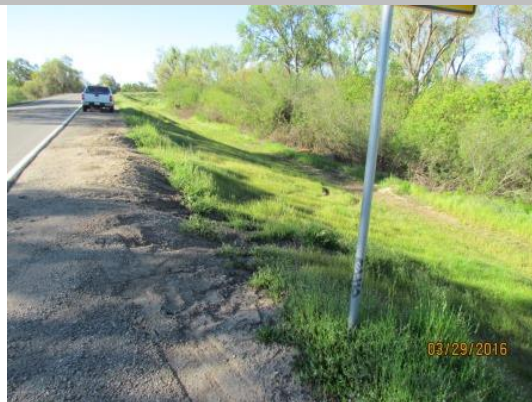
Photo 1 of 2 : FA_2016_RD1001_38_78_20160906_00028.jpg

Ruts on waterside slope due to vehicles. Spring 2016.

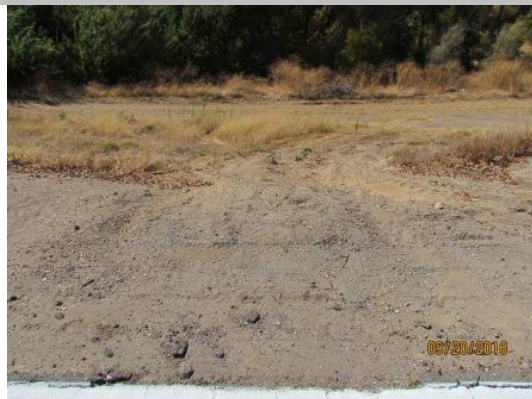
Photo 2 of 2 : FA_2016_RD1001_38_78_20160926_00069.jpg

Ruts still there on waterside slope due to vehicles. Fall 2016.

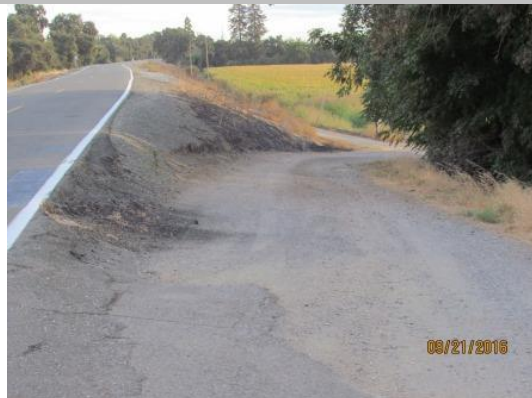
Photo 1 of 1 : FA_2016_RD1001_38_36_20160926_00081.jpg

View of vertical cut for ramp in the landside levee slope looking upstream. Fall 2016.

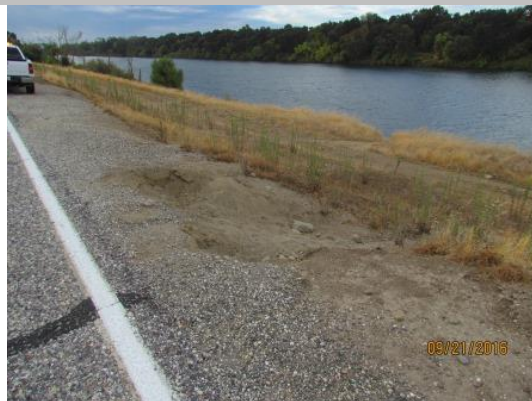
Photo 1 of 1 : FA_2016_RD1001_38_54_20160927_00089.jpg

View of vehicle ruts in levee shoulder on the waterside looking downstream. Fall 2016.

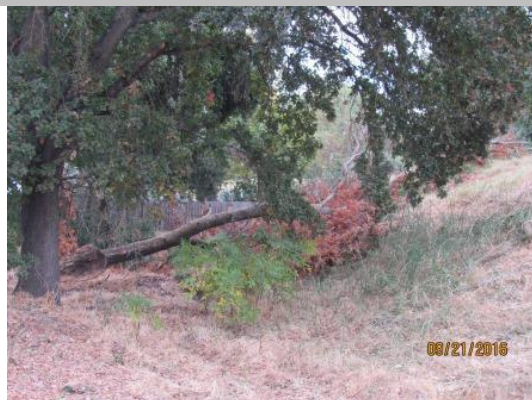
Photo 1 of 1 : FA_2016_RD1001_38_49_20160927_00091.jpg

View of a downed tree on the landside levee toe and slope. Fall 2016.

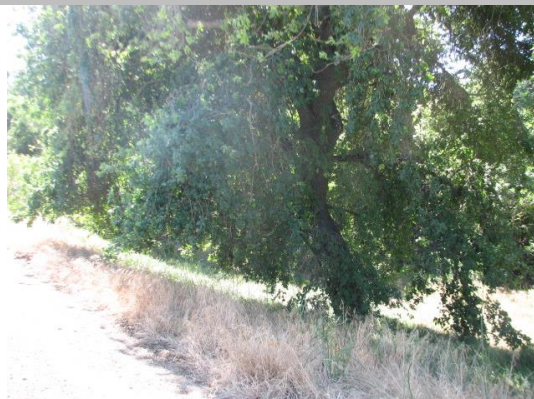
Photo 1 of 1 : FA_2016_RD1001_38_151_20160906_00030.jpg

Trees need to be trimmed up at least 5 feet. Spring 2013

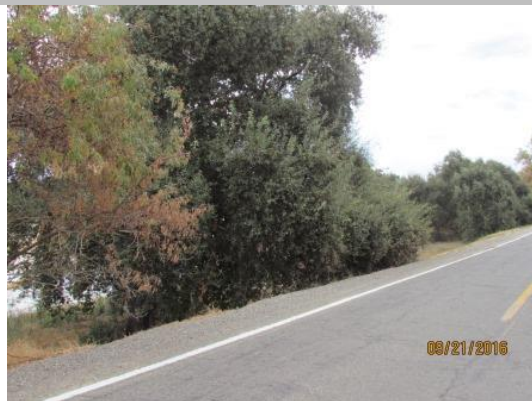
Photo 1 of 1 : FA_2016_RD1001_38_58_20160927_00092.jpg

View of landside tree that need the limbs trimmed up 5' above the slope for visibility and access. Fall 2016.

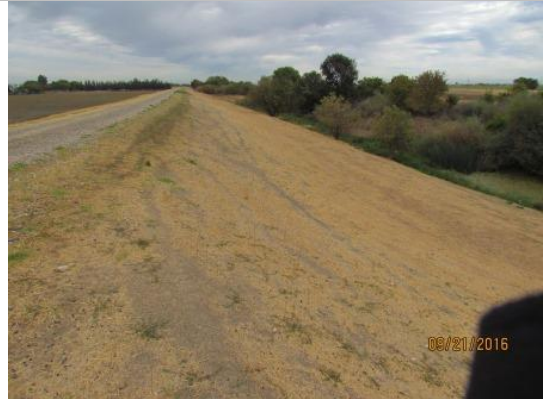
Photo 1 of 1 : FA_2016_RD1001_40_16_20160923_00038.jpg

View of maintained annual grasses, water side, looking upstream. Fall 2016.

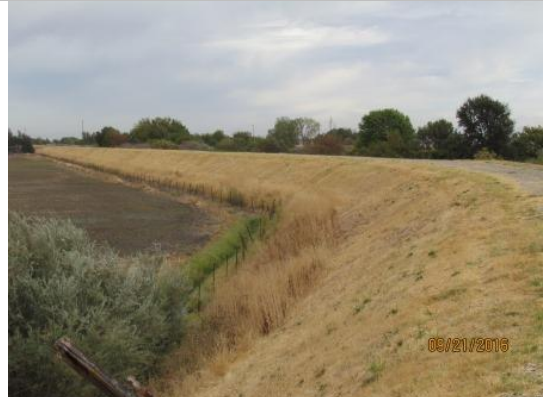
Photo 1 of 1 : FA_2016_RD1001_40_17_20160923_00036.jpg

View of maintained vegetation. Fall 2016.

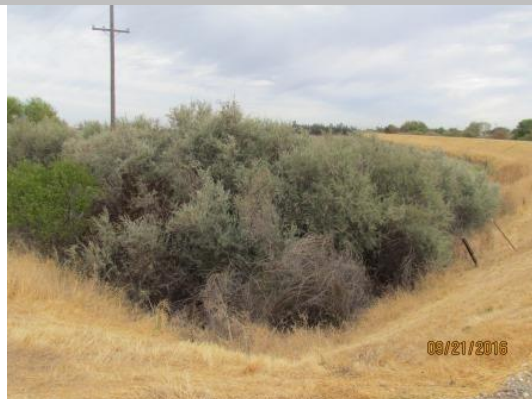
Photo 1 of 1 : FA_2016_RD1001_40_18_20160923_00035.jpg

View of trees that need to be trimmed for visibility on the landside looking upstream. Fall 2016.

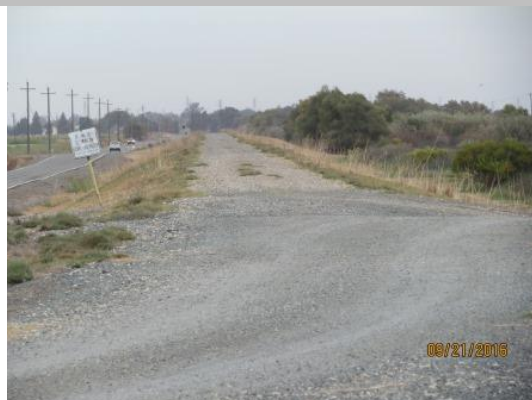
Photo 1 of 1 : FA_2016_RD1001_40_8_20160923_00041.jpg

View of crown where there is cross traffic looking upstream. Monitor this area and fix as needed.

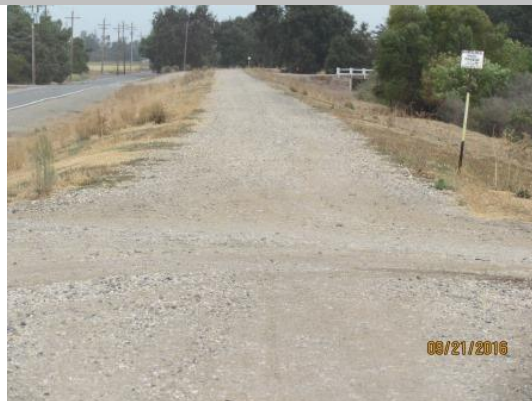
Photo 1 of 1 : FA_2016_RD1001_40_7_20160923_00042.jpg

View of crown where there is cross traffic looking upstream. Monitor this area and fix as needed.

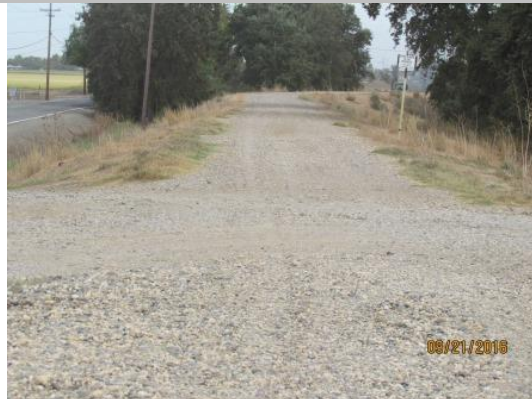
Photo 1 of 1 : FA_2016_RD1001_40_19_20160923_00043.jpg

View of crown where there is cross traffic looking upstream. Monitor this area and fix as needed.
